Structural degradation of a large composite wind turbine blade in a full-scale fatigue test

Xiao Chen

Section of Wind Turbine Structures and Component Design, Department of Wind Energy,
Technical University of Denmark, Frederiksborgvej 399, 4000 Roskilde, Denmark

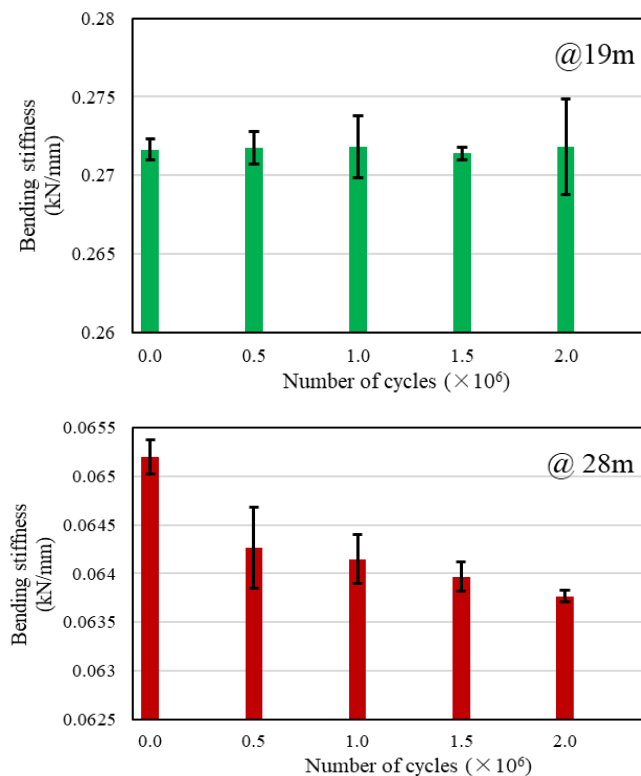
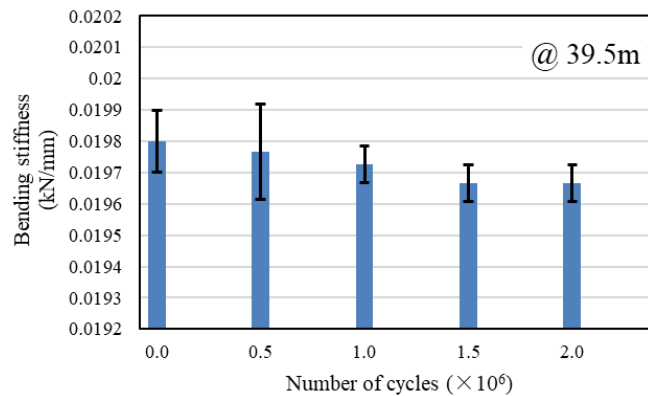
It is found that the blade exhibited different stiffness degradation patterns at different cross sections. As shown in Fig. 2, the bending stiffness of the blade from 0 to 19 m did not show obvious degradation during fatigue test. However, the bending stiffness of the blade from 0 to 28 m and that from 0 to 39.5 m showed very similar degradation pattern to composite materials, which is fast at the early stage and slow at the following stage. In addition, it is noted that the overall stiffness degradation is shown to be not significant.

Fig. 2 Degradation of bending stiffness at different blade sections

This trend may be explained by the stress/strain levels experienced by different sections. During the fatigue test, the blade was stressed most in the middle region approximately from 19 to 34 m where stiffness degradation is expected to be significant. This observation can be also verified by static load test as shown in Fig. 3.

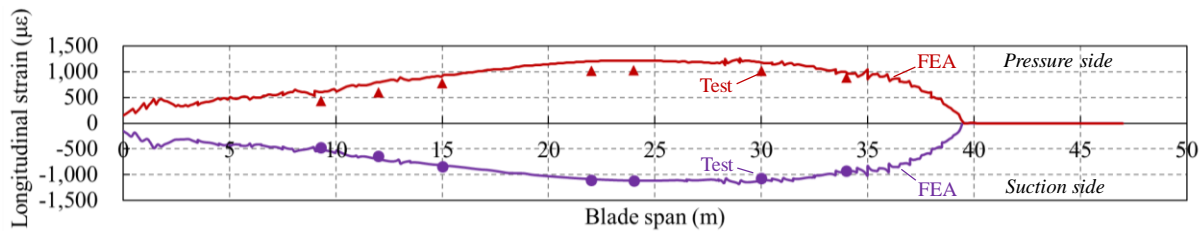
Fig. 3 Longitudinal strain distribution under static loads

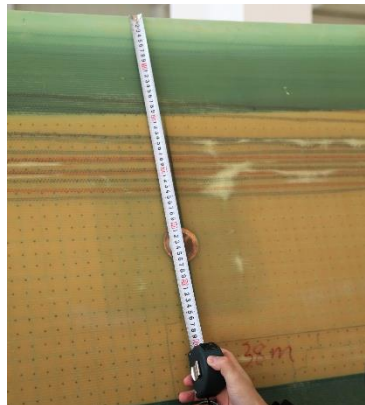
Post-fatigue damages observed in the blade include the whitening of sandwich skins and cracks in core materials, and fracture of composite materials in the root transition region despite the calculated low stress level there. The findings from this study suggest that the change of damping ratio might be a more practical metric than stiffness degradation to indicate fatigue damage. In addition to fatigue properties of composite materials at a coupon level, special attention has to be paid to fatigue characterization of structural discontinuities, such as material change, geometric transition and manufacturing-induced defects, etc., in order to better understand fatigue behaviour of large rotor blades at a structural level.

Fig. 4 The whitening of sandwich skins after fatigue test
