Structural degradation of a large composite wind turbine blade in a full-scale fatigue test

DTU Wind Energy, SAC Section

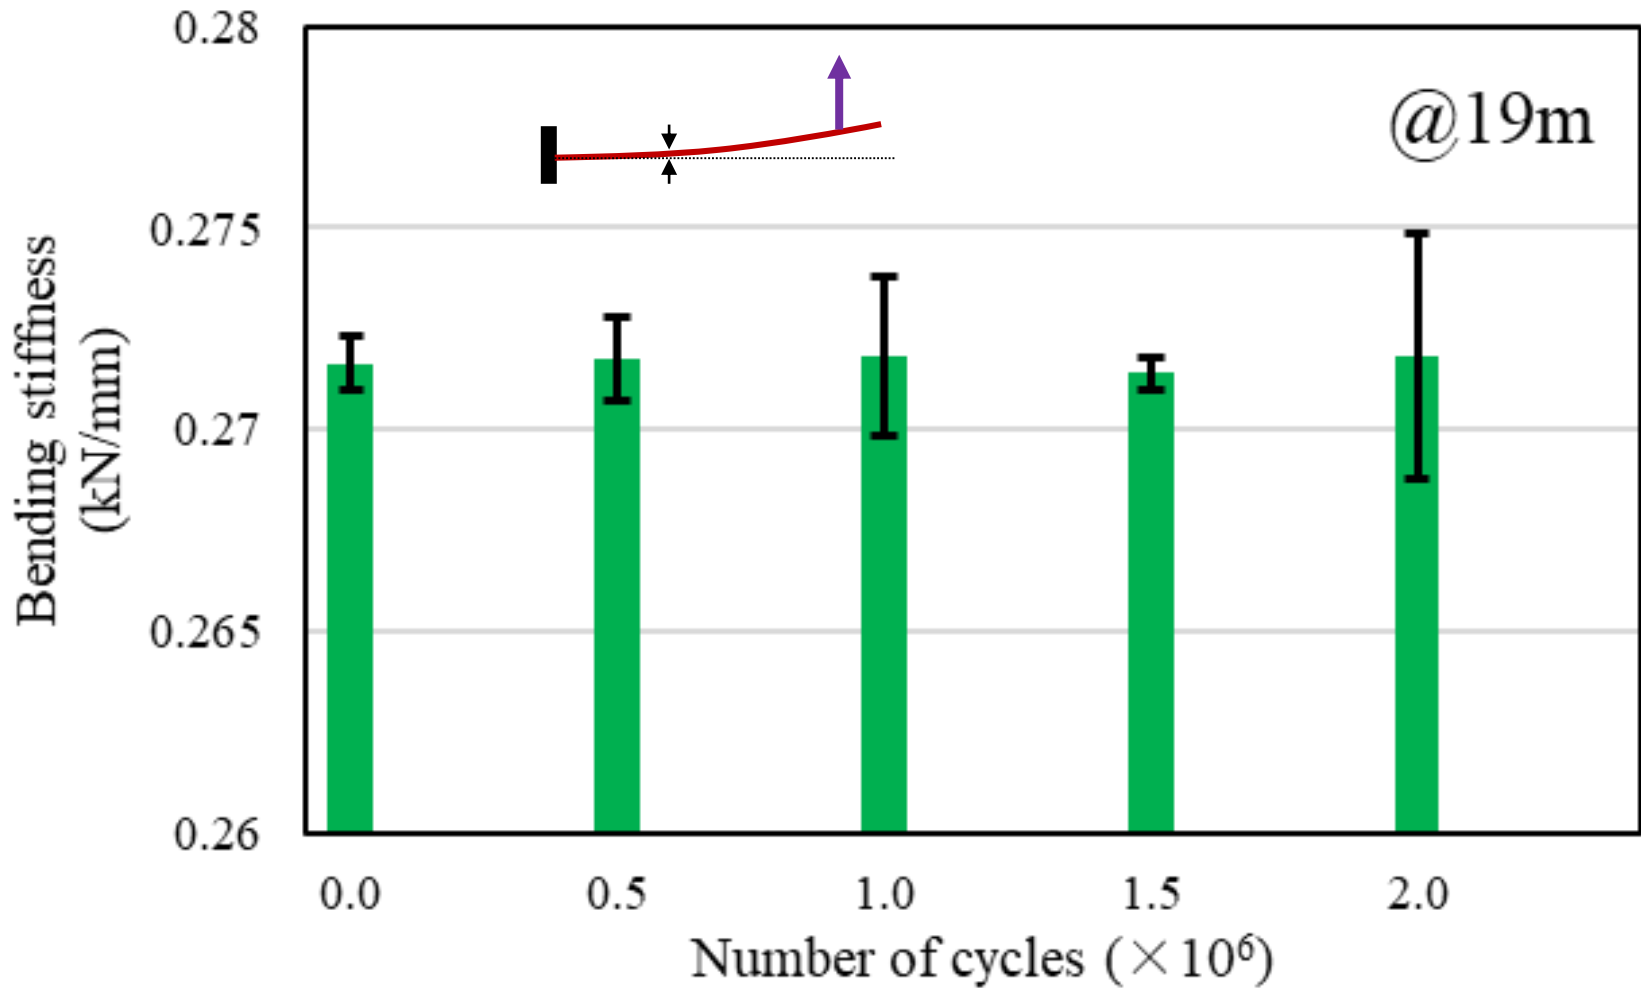
Stiffness degradation @ 19m

- A full-scale blade shows a *stiffness degradation pattern similar to* composite materials as the flap-wise bending stiffness is controlled by fatigue properties of UD composites.
- The changes of natural frequencies due to fatigue are negligible (*<1%*). However, *the changes of damping ratios are significant* and they might be *more practical metrics* to indicate the overall fatigue damage.
- Significant increase of the damping ratio in *torsional mode* might be due to fatigue damage in *angle-fiber composites* and *sandwich core materials* used in the blade shells.
- The existence of potentially *critical cracks in local laminates* cannot be reflected by the changes of global structural properties.

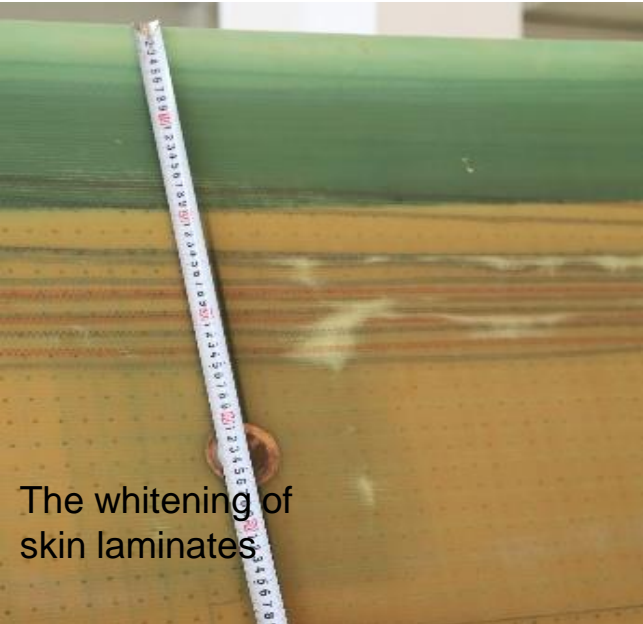
The whitening of skin laminates

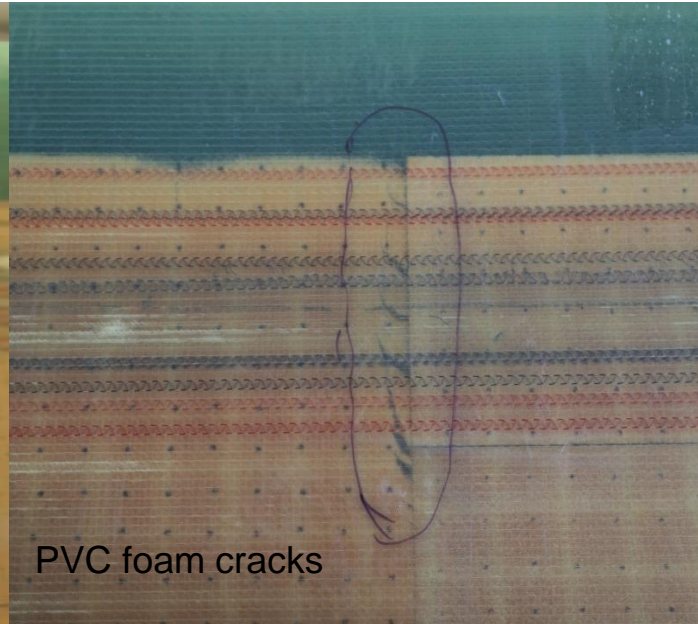
PVC foam cracks

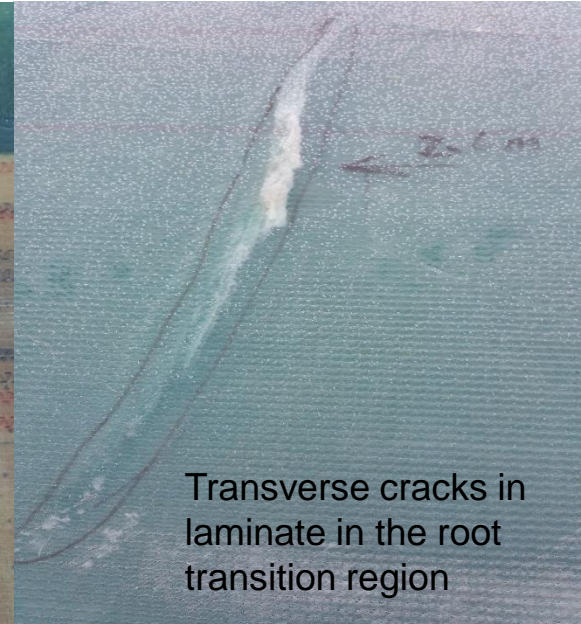
Transverse cracks in laminate in the root transition region
