# Multi-scale testing of fibre reinforced concrete under corrosion deterioration

Victor Marcos Meson<sup>123</sup>, Alexander Michel<sup>1</sup>, Anders Solgaard<sup>2</sup>, Carola Edvardsen<sup>2</sup>, Gregor Fischer<sup>1</sup>, Henrik Stang<sup>1</sup>

05/10/2016

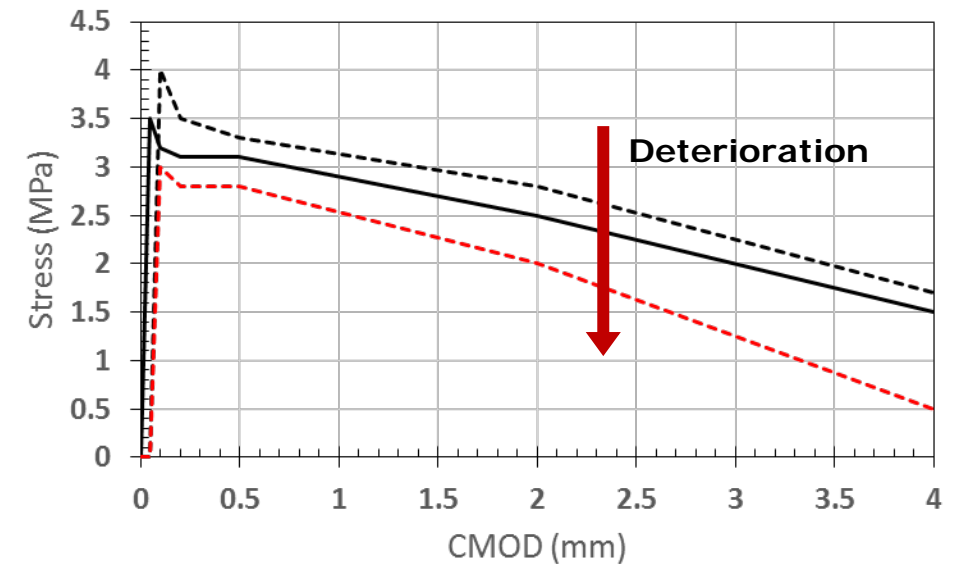
### AIM

Identify changes in the residual tensile strength (toughness) after exposure

— Initial    - - - Reference    - - - Exposed

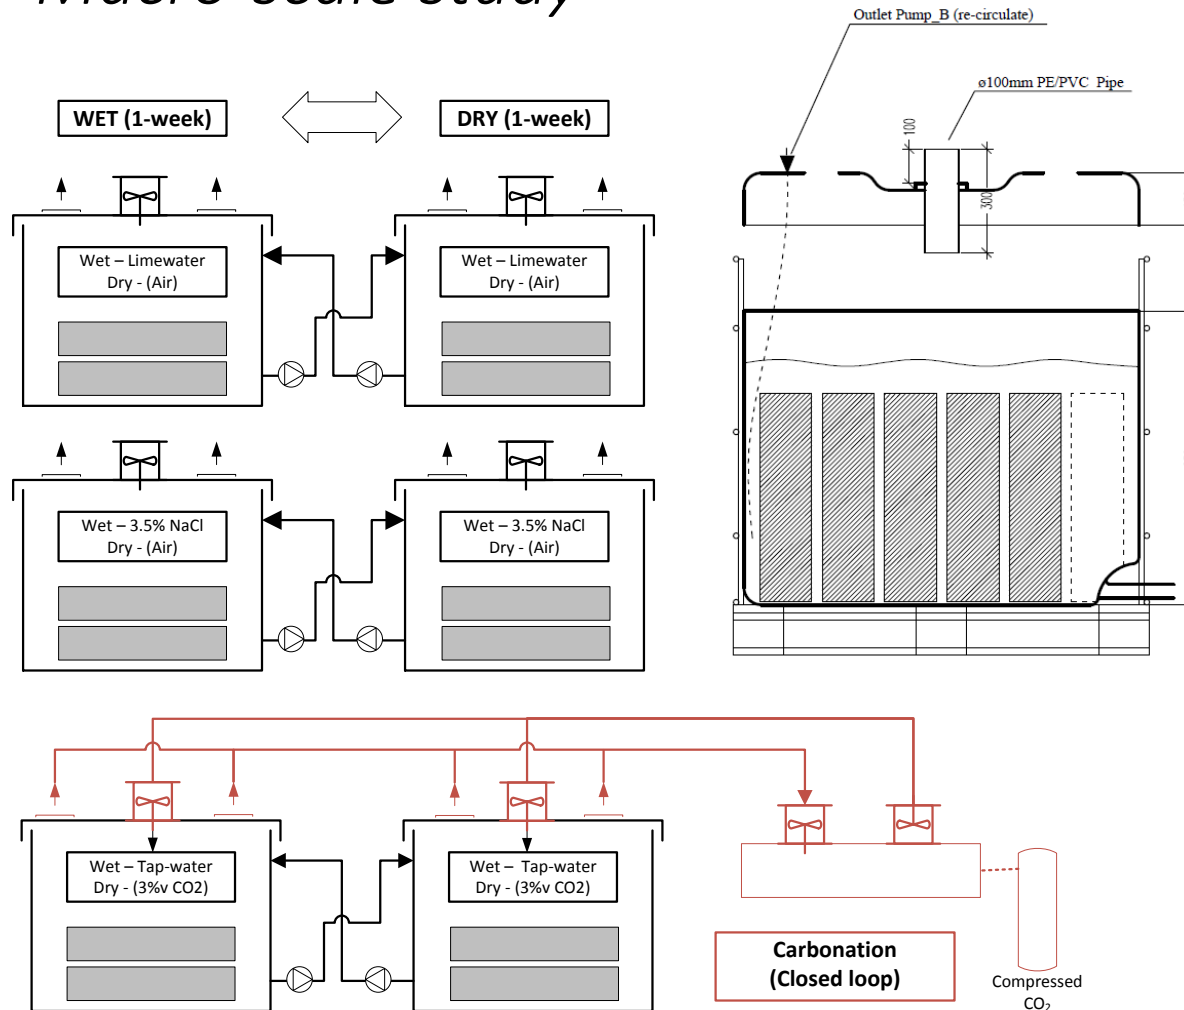
### Exposure method

- Wet-dry cycles (48h-cycle)
- 2 years (1-year, 2-year test)
- $\approx 9\text{m}^3$  total capacity (10 IBC tanks)

### Amount of specimens

- 230 beams (150x150x600mm)
- 230 cubes (150mm)
- Total  $3.8\text{m}^3$  ( $\approx 9$  ton.)

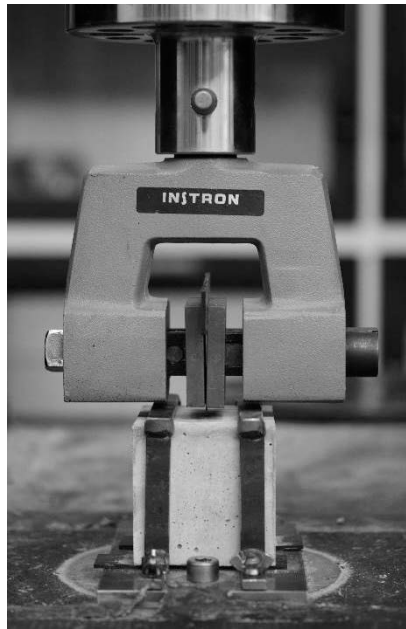
Single fibre pull-out tests  
+  
Exposure

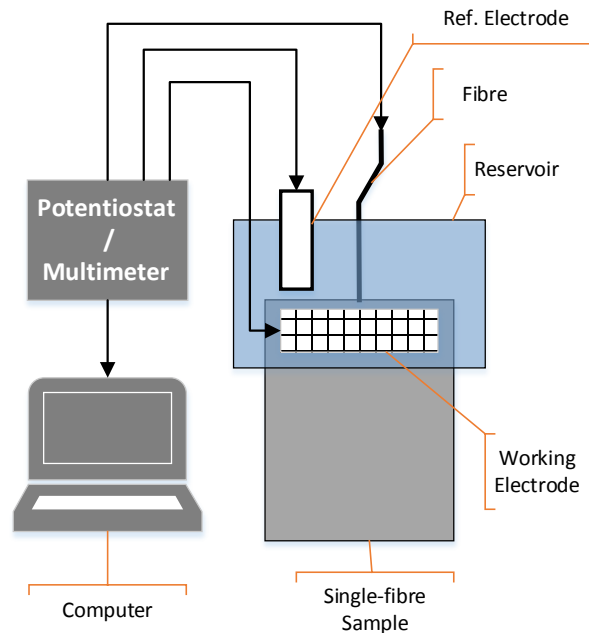
Linear Polarization Resistance  
+  
Electrochemical Impedance Spectroscopy

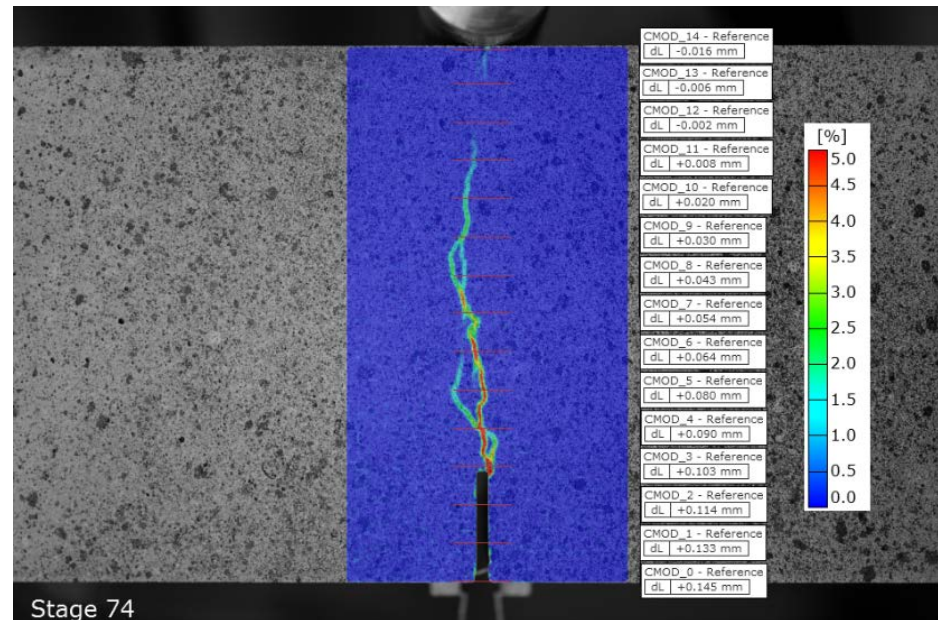
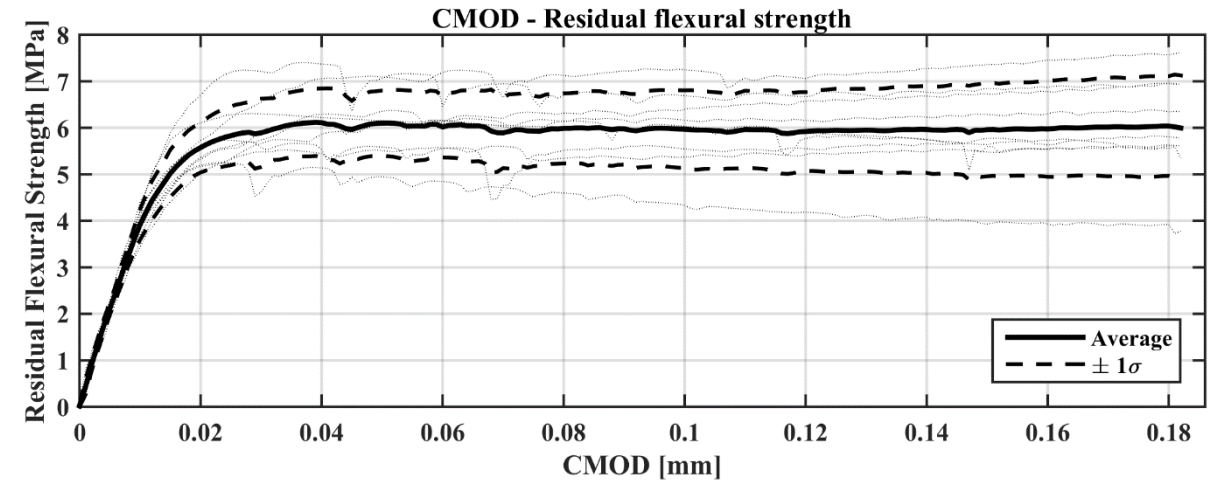
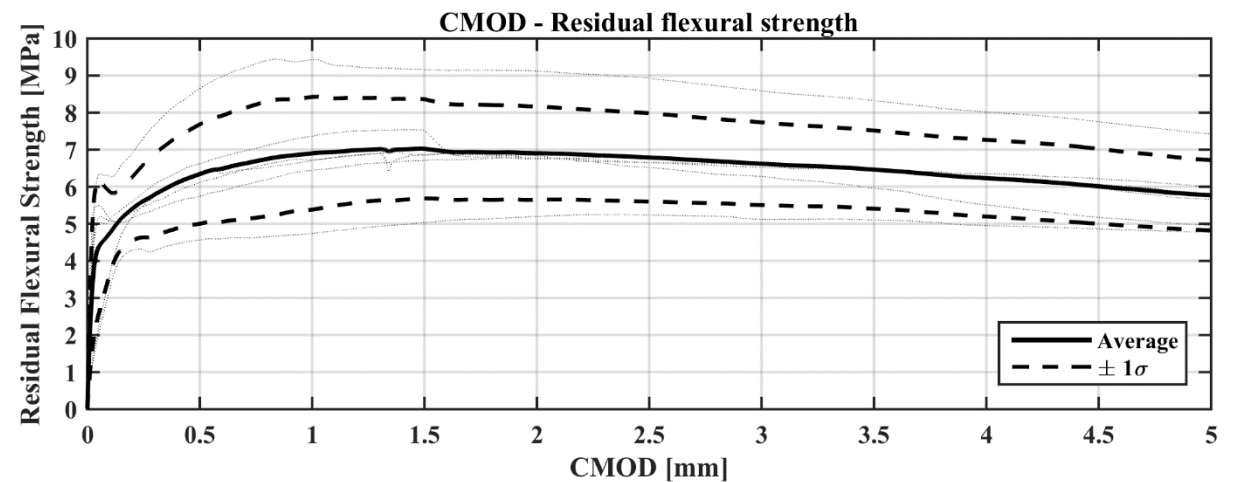
Preparation of specimens (cracking)

Characterization of crack propagation

- Digital Image Correlation (DIC)

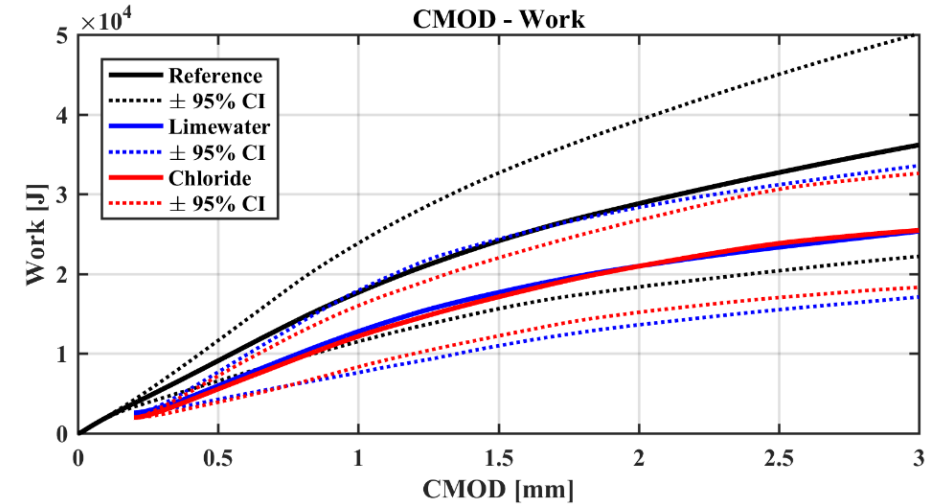
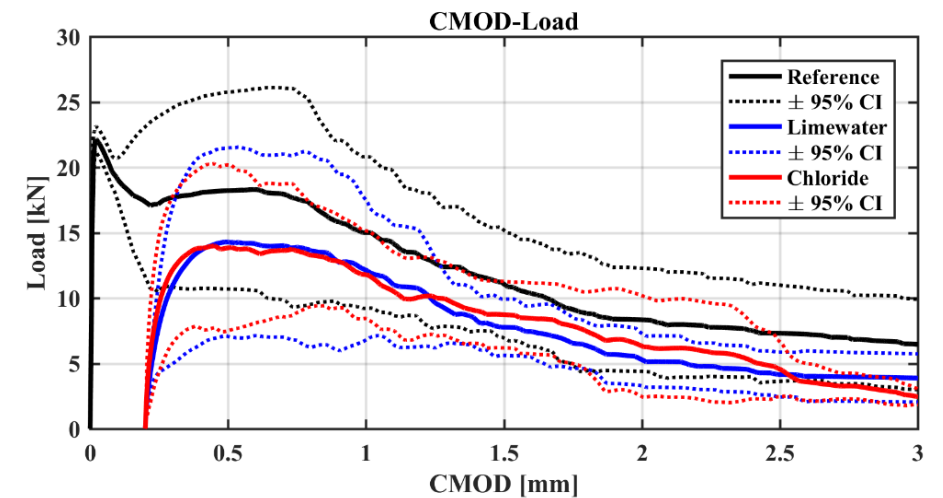
### Observations

- Limited impact of exposure
- Large variability within groups
- Limited corrosion inside crack

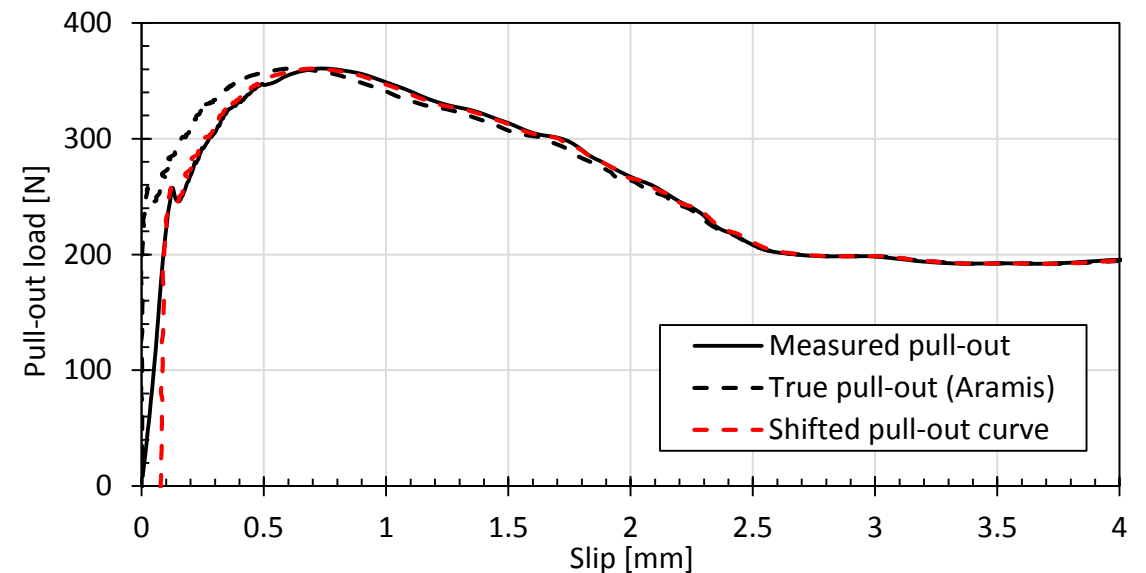
### Observations

- Underestimation of bond stiffness (DIC)
- Error  $\approx$  80 $\mu$ m  $\rightarrow$  Important under SLS!!
- Restoration of initial bond after healing

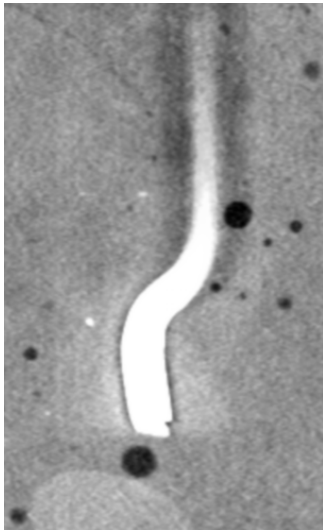
**Original**

**Interfacial damage** characterized by **X-ray computed micro-tomography ( $\mu$ CT)**

- DTU 3D Imaging centre (Carsten Gundlach)
- Resolution 45 $\mu$ m (ZEISS XRadia 410 Versa)

**Damage at interface can be measured without invasive/destructive methods**
