Structural degradation of a large composite wind turbine blade in a full-scale fatigue test

Xiao Chen

Section of Wind Turbine Structures and Component Design, Department of Wind Energy,
Technical University of Denmark, Frederiksborgvej 399, 4000 Roskilde, Denmark

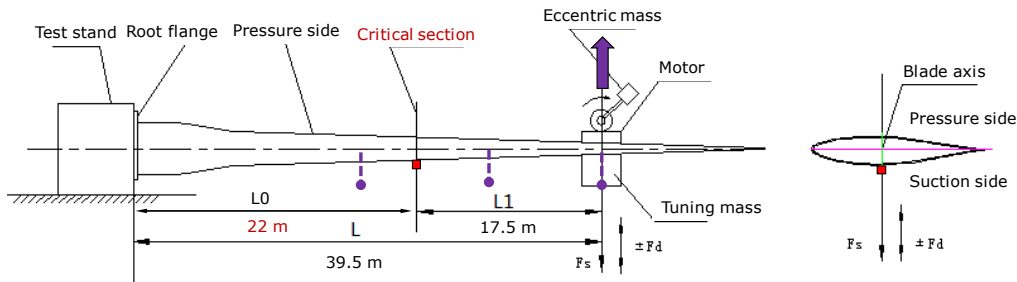
Fig. 1 Fatigue test setup

with the suction side primarily under compressive stress and pressure side under tensile stress, see Fig. 1. The applied loads are increased to reduce the number of cycles to 2.0 million cycles. Bending stiffness of the blade is measured at different span-wise sections during the fatigue test in order to measure its possible degradation. Natural frequencies and damping ratios are measured both before and after fatigue test. Post-fatigue damage of the blade is examined throughout the blade.
